PARNAGIAN ARCHITECTS

FIELD REPORT

Project	Two Hill Residence	Project No.	PA-23-Green
Date of Visit	October 3, 2023	Time	9:00 AM
Report No.	1	Date Prepared	October 11, 2023
		Prepared By	Travis Pummer

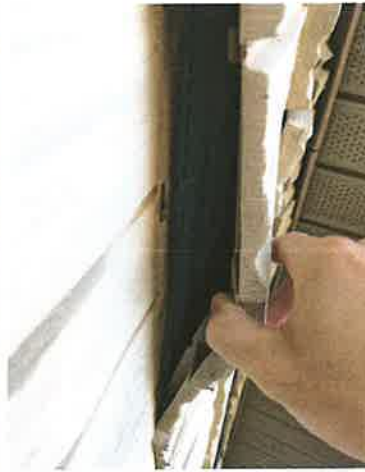
Fig. 2

During the addition, it appears a 1-inch layer of rigid insulation was added to the entire perimeter of the original house. The entire main floor of the home was finished with vinyl shake siding. (Fig 2)

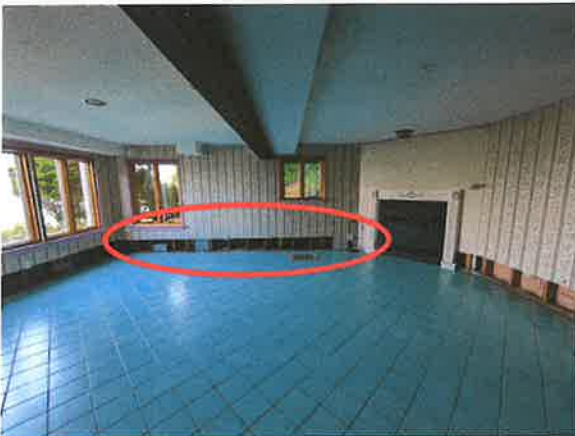
Fig. 4

- C. The north and east basement walls appear to have no insulation in the stud cavities, however further investigation will need to be conducted to determine the conditions at all exterior walls. (Fig 4)

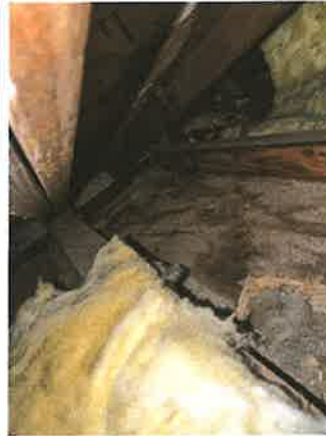
Fig. 5

- A. The northwest corner of the master bedroom appears to have settled approximately 3-4 inches below the level of the northeast corner of the bedroom. (Fig 3)
- B. We suspect this settlement caused the sliding glass doors to be out of plumb/square creating a gap and the lower latch side of the sliding door. (Fig 1)
- C. The hot tub deck is sloping significantly to the north and west. (Fig 7)
- D. The insulation in the attic is inconsistent and appears to have been damaged and/or removed over time. (Fig 5)

- D. The fiberglass batt insulation that has been installed in the attic had a thermal resistance rating of R-13 prior to any damage or partial removal. Modern building codes require a thermal resistance rating of R-60. The current condition of the attic insulation appears to have nearly zero thermal insulation value. We consider this a "non-issue" as we assume we will be removing the existing roof to accommodate a second story (Fig 5). None of the existing roof framing or attic insulation would be repurposed.

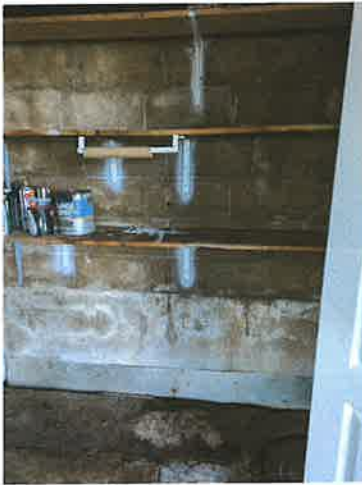
Fig. 6

- F. The second furnace located in the unconditioned and uninsulated storage closet of the car port is not a recommended environment for the efficiency and longevity of the unit. Additionally, the home is divided into two zones, one to the east, and one to the west. The owner has indicated a preference for the zones to be divided by floor.
- G. The 4-inch concrete masonry units on the back wall of the storage closets at the carport show signs of water infiltration. (Fig 6)
